TankCam® Demo for Major Oil Client in Australia

Tanknology, Inc. – the US based global leader in forecourt testing – is featuring a series of case studies that showcase significant projects performed by Licensees in its worldwide network.

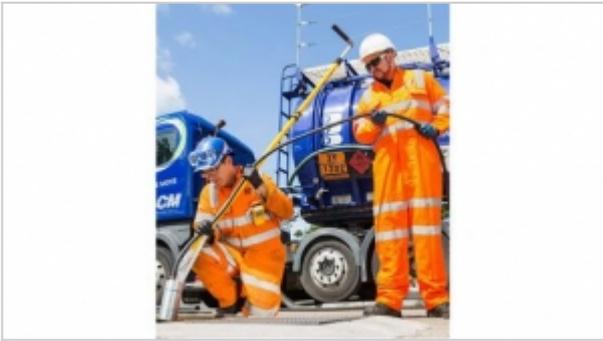
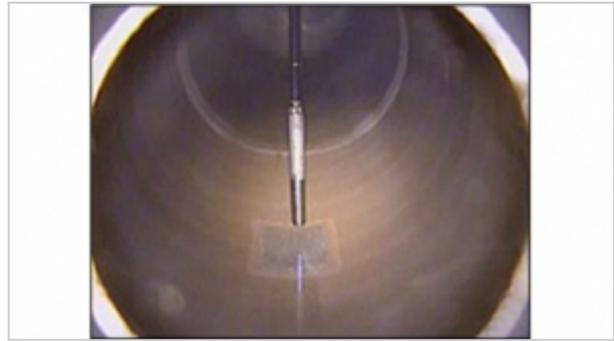
In the summer of 2016 Tanknology Australia completed a TankCam® demo for a large Major Oil company at a new retail fueling site on the Western outskirts of Sydney. The site has eight USTs, seven of which were inspected by the TankCam. They were 110,000 liter (approximately 29,000 gallon) double-walled fiberglass tanks. Two of these were split-compartment tanks.

Four of the site's tanks were to be filled with diesel, one with E10, one with ULT 95, one with Premium 98, and the tank not tested was an AD Blue tank. As the site was a new build and had not yet had its first fuel drop, the inspection verified that the water had been extracted and that no tools, landscaping, construction, or backfill materials had been left behind in the tank.

The inspection also checked for anomalies in the tank walls or changes in overall tank shape. This process is similar to TankCam inspections Tanknology USA performs for new-build sites for its clients in the US. Each tank was inspected for approximately 30 minutes. Five of the seven were reported to be in good condition with minimal water left behind. TankCam inspections revealed that two tanks required additional water removal, and one of these was observed to possibly have green algae on the tank bottom.
