TankCam® Demo for Major Oil Client in Australia

Tanknology, Inc. – the US based global leader in forecourt testing – is featuring a series of case studies that showcase significant projects performed by Licensees in its worldwide network.

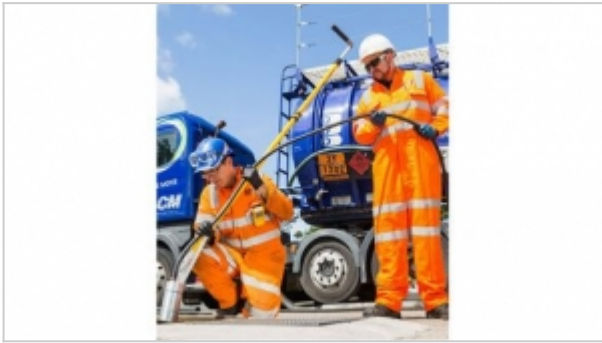
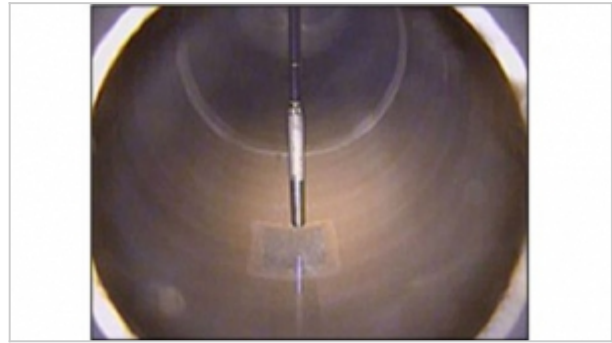
Four of the site's tanks were to be filled with diesel, one with E10, one with ULT 95, one with Premium 98, and the tank not tested was an AD Blue tank. As the site was a new build and had not yet had its first fuel drop, the inspection verified that the water had been extracted and that no tools, landscaping, construction, or backfill materials had been left behind in the tank.

The inspection also checked for anomalies in the tank walls or changes in overall tank shape. This process is similar to TankCam inspections Tanknology USA performs for new-build sites for its clients in the US. Each tank was inspected for approximately 30 minutes. Five of the seven were reported to be in good condition with minimal water left behind. TankCam inspections revealed that two tanks required additional water removal, and one of these was observed to possibly have green algae on the tank bottom.
