Rampant Diesel Corrosion in Underground Storage Tanks Containing Ultra-low Sulfur Diesel

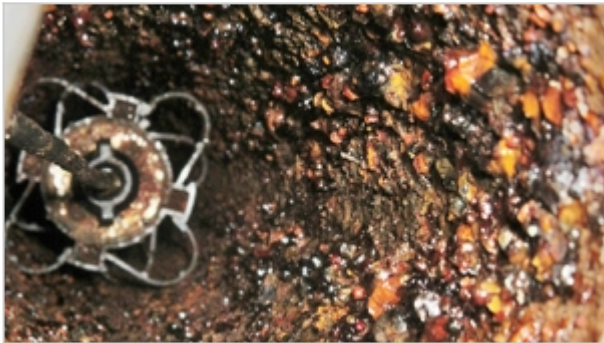
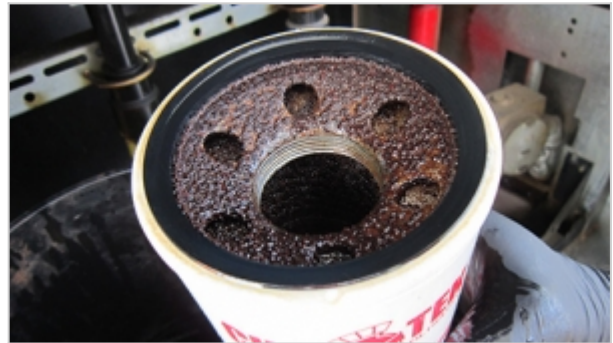
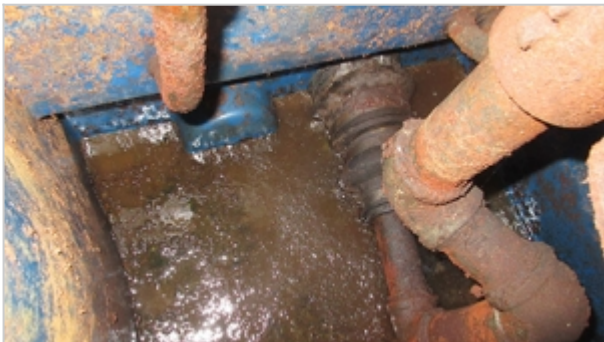
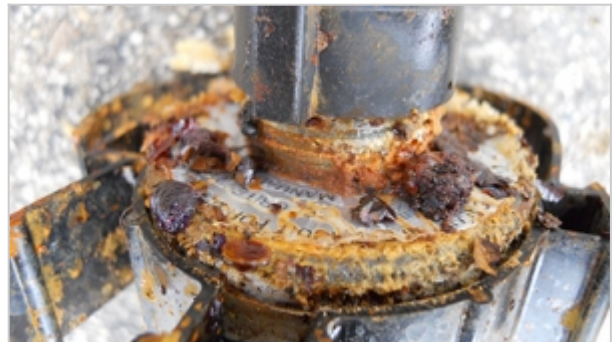
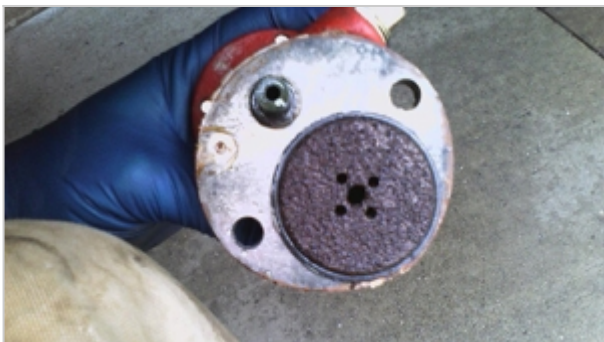
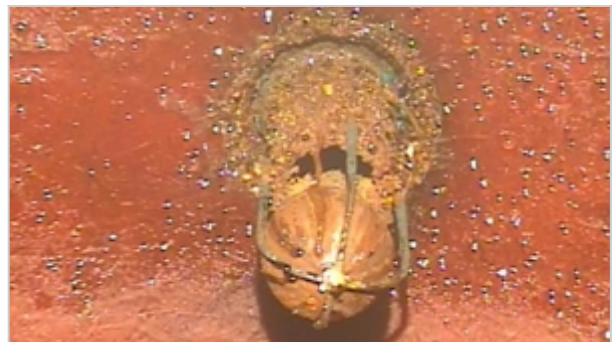
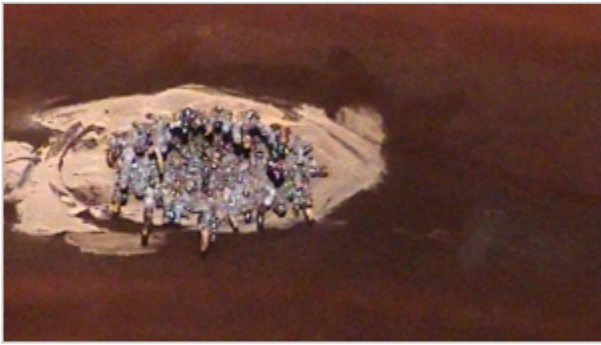
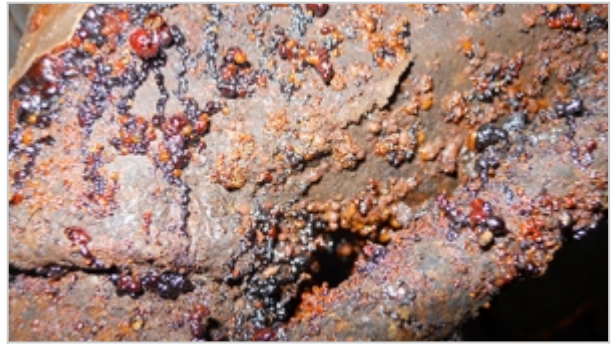
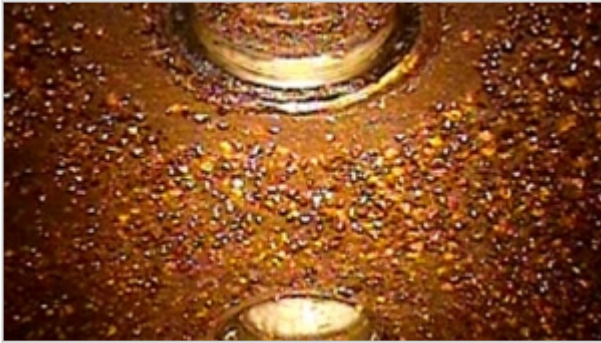
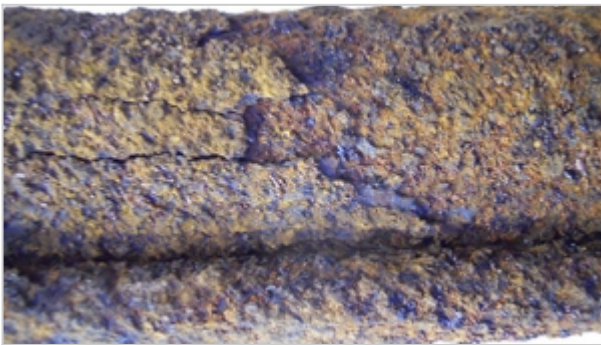
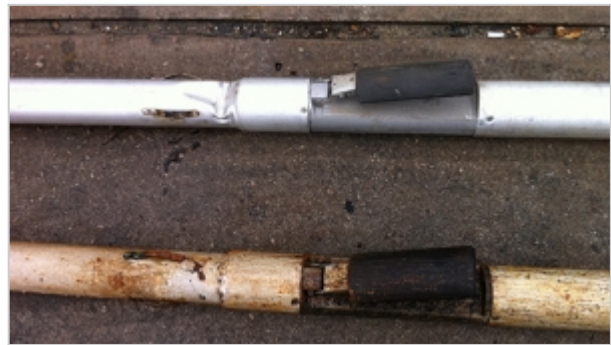
Our work consisted of collecting fuel, water, and vapor samples, and inspecting fuel filters and the tank system access points for signs of corrosion. We also used our TankCam® remote internal video system to record the conditions inside the tanks. The images you see here are representative of the extreme conditions we discovered.

Unlike the mild orange-colored oxidation that would be typical for corrosion in this environment, we have seen large tubercles and nodules that can vary in color from yellow to orange to reddish brown and even black. The metal components in the vapor space of both steel and fiberglass tanks, including bungs, risers, caps, plugs, STP shafts, ball float assemblies, and flapper valves have all exhibited this unusual form of aggressive corrosion.

It has not been uncommon to find a severely corroded ball float assembly or bungs completely covered in tubercles, some of which can be up to an inch long. On one occasion, the top of a riser pipe broke completely in half as a result of the corrosion.

We have pulled completely corroded STP shafts from tanks, and in some cases are not even able to remove them due to the excessive corrosion in the riser. Layers of corrosion and tubercles have built up so severely that the inside of the riser is no longer wide enough for the STP motor to be removed or serviced.

We have seen the same problem with ATG probes; corrosion build up in the riser pipe can make it impossible to remove the ATG floats. Consequently, the probes and STP’s remain in the corrosive environment of the upper vapor space, either unable to be serviced, or in some cases replaced with smaller diameter ATG floats once the original floats are knocked off and left to fall down into the tank.

- Perform regular visual inspection inside the ATG or other riser pipes accessible from grade, looking for any sign of potential corrosion.
- Remove and inspect the ball float or flapper valve overfill prevention equipment – perhaps incorporated as part of a periodic inspection such as PEI RP900.
- The single biggest thing to focus on is *managing water*. Operators should do everything possible to keep water from entering the tank:
 - Remove standing water, ice and/or snow around tank fill covers.
 - Make sure all opening bungs, caps and cord grips are tight and replace caps or gaskets as needed.

- Keep fill and vapor recovery spill buckets clean. Pump out any water; clean out excess fuel and dirt. Don't drain water into tanks!
- Change filters frequently, especially if slow-flow occurs, and look for signs of corrosion on the filter and housing.
- Pay close attention to leak detection equipment and call for immediate service if any leak alarms or conditions occur.
- Verify that tank vents have rain caps.
- Avoid prolonged periods of low tank volume to minimize tank water from condensation.
- Check tanks for water bottoms frequently, especially before and after deliveries.
- No detectable water is acceptable in a diesel tank. It should be removed as soon as possible. Removed water should be tested for microbes and, if detected, appropriate corrective action should be taken immediately.

One of EPA's recommendations is to perform an internal video inspection of the suspect tanks. Tanknology's TankCam® remote visual tank inspection service can be used for this purpose, as it was for the EPA study. The TankCam provides a clear picture of what's happening inside the tank without having to empty it. All of the interior photos in this article were captured via the TankCam.
