## **KPS works with BP Aral Gotha to replace metal piping, protecting people and the environment**

This case study tells the story of a project completed before the lockdown went into place, where KPS worked with BP Aral in Germany (Gotha) to replace their previously installed metal pipework with our corrosion-free double wall polyethylene piping, protecting people and the environment.

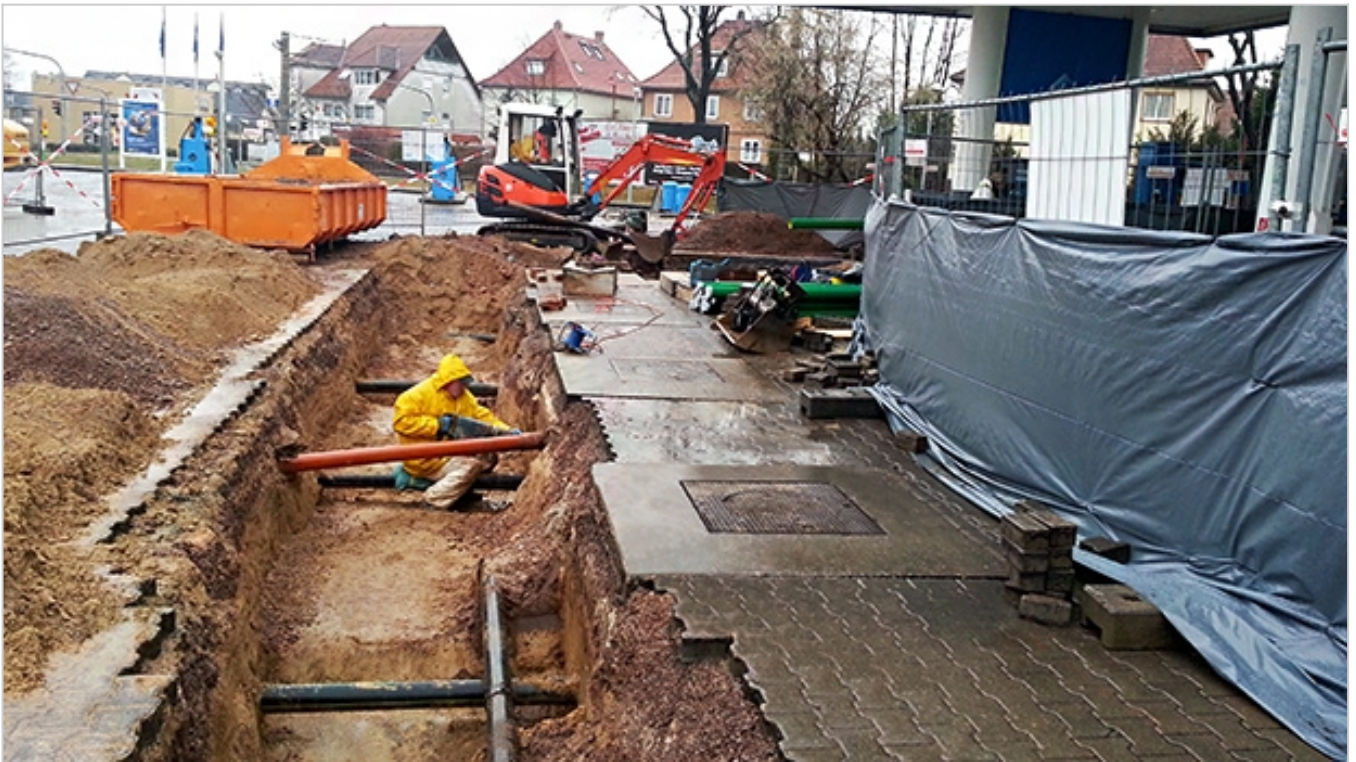
The previously installed steel fuel piping had become damaged as a result of rust over the last twenty years, causing the pipes to leak. No down time or interruption of sales was a key requirement of this project, so a solution had to be put in place before the old piping was disconnected.

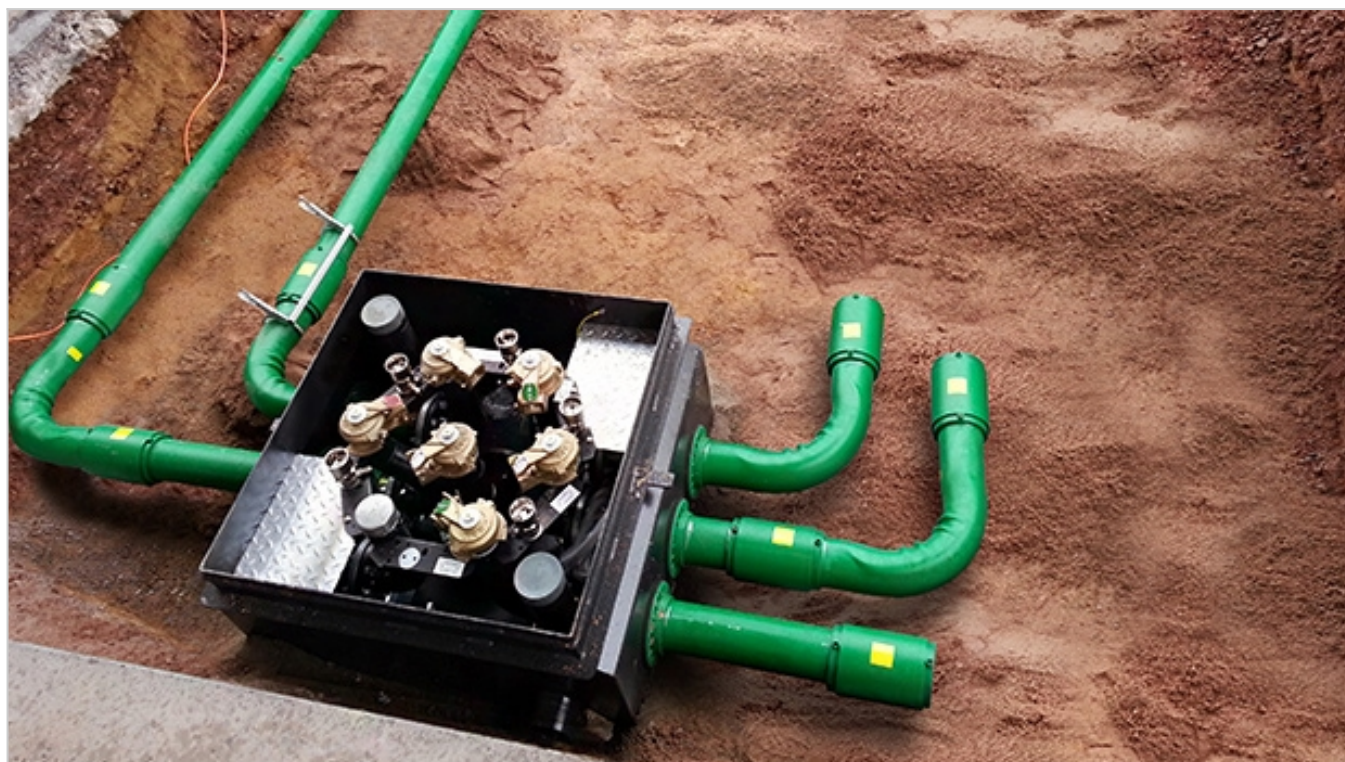
KPS easy install double wall piping was installed one level above the existing steel pipes, then once the plastic piping was in position, the tank was disconnected from the old piping and connected to the new KPS piping above, preventing interruption of fuel sales.
